'Balancing' a Generator at a Hydro Electric Plant

Just two years after installation of a new turbine-generating unit at the 93-MW Thompson Falls hydro project, PPL Montana LLC noticed increasing vibration values on the generator guide bearing. After several unsuccessful attempts to correct the problem, plant personnel adjusted the clearance on the guide bearings. Since that work was completed, the unit has operated within acceptable vibration values.

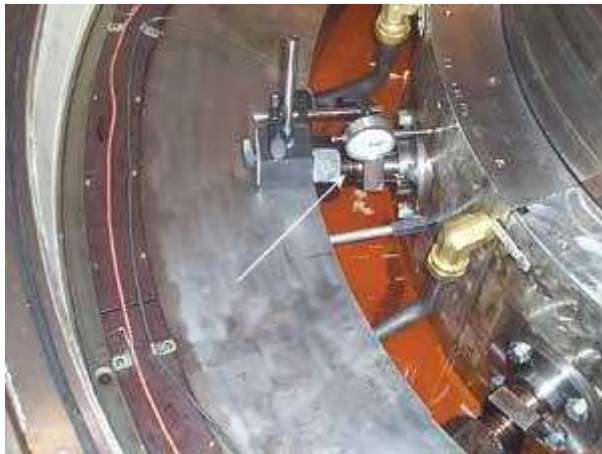
After two years of operation, vibration values on the generator guide bearing began to creep up. By 2000, these values were around 10 mils and climbing. Over this same time period, the turbine guide bearing vibration did not show much change.

Because the diametrical clearance for this generator guide bearing was 10 mils, the alarm point on the PCS originally was set at 7.5 mils. (Industry practice says to limit vibration in a bearing to 75 percent of the diametrical clearance.) Over the years, PPL Montana consulted with the generator manufacturer and repeatedly moved up the vibration limit. The vibration limit was increased to 8 mils in 1998, 10 mils in 2000, and then 12 mils in 2001.

Measurements of diametrical clearance (see arrow) on the generator guide bearing on a unit at 93-MW Thompson Falls revealed the clearance had doubled over seven years of operation. Adjusting the bearing back to the original clearance solved a problem with extreme vibration.

The next step was to check the clearance between the bearing pads and the journal on the generator shaft. To avoid losing the original center established during construction and to keep the shaft from moving when readings were taken, Young blocked the shaft. Readings were taken using a feeler gauge between the adjusting stud and the back side of the pad, around the entire bearing assembly. This particular bearing had ten pads, so four were used to block the shaft and the other six were measured. Based on these measurements, Young determined that the diametrical clearance had increased to about 20 mils, or double from the original installation.

Plant personnel then adjusted the bearing back to the original clearance of 5 mils per side or 10 mils total diametrical clearance. This was accomplished by loosening the lock nut and adjusting the stud that pushes on the bearing pads. The unit was put back on line, and

immediately the vibration dropped drastically, back to what originally was recorded during start up and commissioning of the unit in 1995 - 3 to 4 mils.
